## A1 WESTERN MOTORWAY, SLOPE PROTECTION

Client: Provincial Government of Niederösterreich

### THE PROJECT

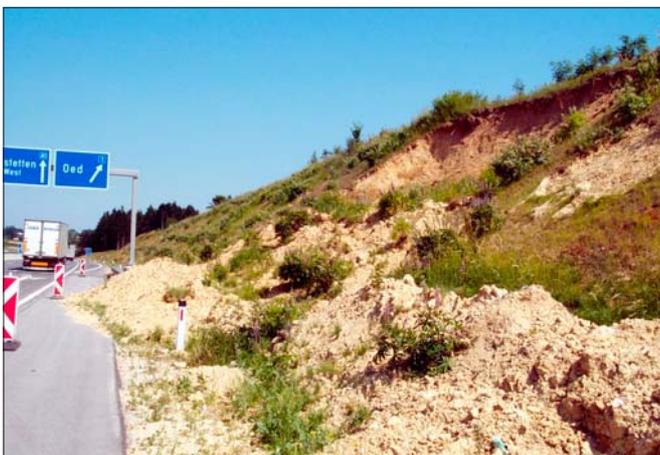
*Images of the A1 Western Motorway, side towards Vienna, at 131.7 km*

In this area, at the slopes of both sides of the motorway, numerous deep reaching, shell-shaped slides occurred at an extent of 500 m. Each one featured a length of up to 40 m, depths of up to 5 m below the original slope line, as well as baggings of up to 4 m. Furthermore, breaking of the grass sward was observed in wide areas.

*Sliding Situation*

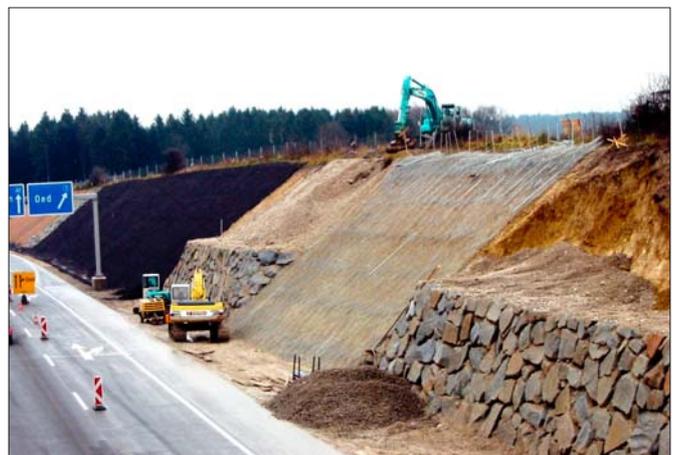
*Reconstruction*

Reconstruction included the use of rock support bodies (stone walls, slope paving), 3-dimensional slope mesh (anchored) and coconut fibre mats.
