RAILWAY LINE STAINACH - ATTNANG, LANDSLIDE STABILISATION KOPPEN STREET

Client: Austrian Railways Infrastructure AG

Development Period: 2009 to 2016

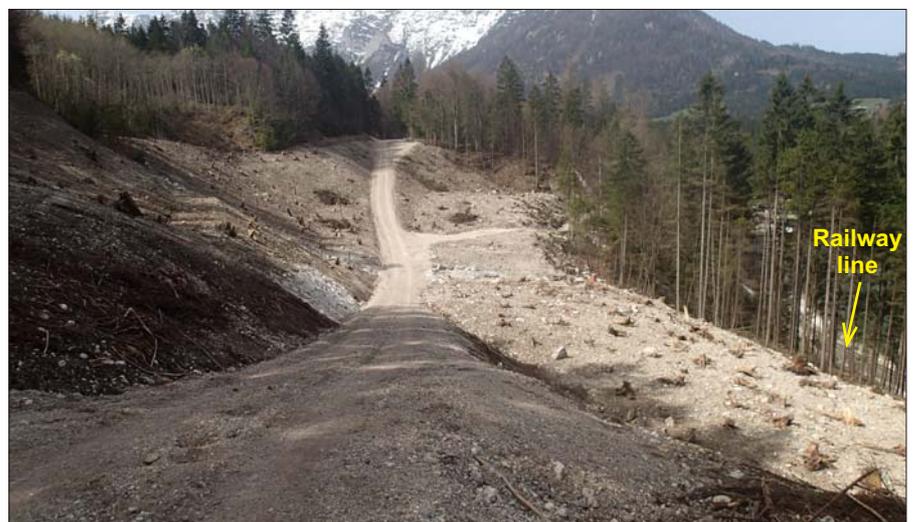
Sliding area after completion of the stabilisation works

The sliding mass extends over a width of up to 180 m and holds a depth of up to 20 m. The slipping mechanism can be described as several, partly deep reaching, combined rotational slides. The technically and economically best stabilisation option was considered as a large-scale excavation at the upper part of the slide body, with the effect of a load relief at the head area. Additionally, the surface has been remodelled in order to improve the drainage situation. The excavated material was used for the upgrade of an existing avalanche barrier in the vicinity of the slide. Thus, the transport and dumping costs could be reduced significantly.
