ARNOLDSTEIN - HERMAGOR RAILWAY LINE, RENEWAL OF THE GAIL BRIDGE

Client: Austrian Railways Infrastructure AG
Development Period: 2017 to 2019

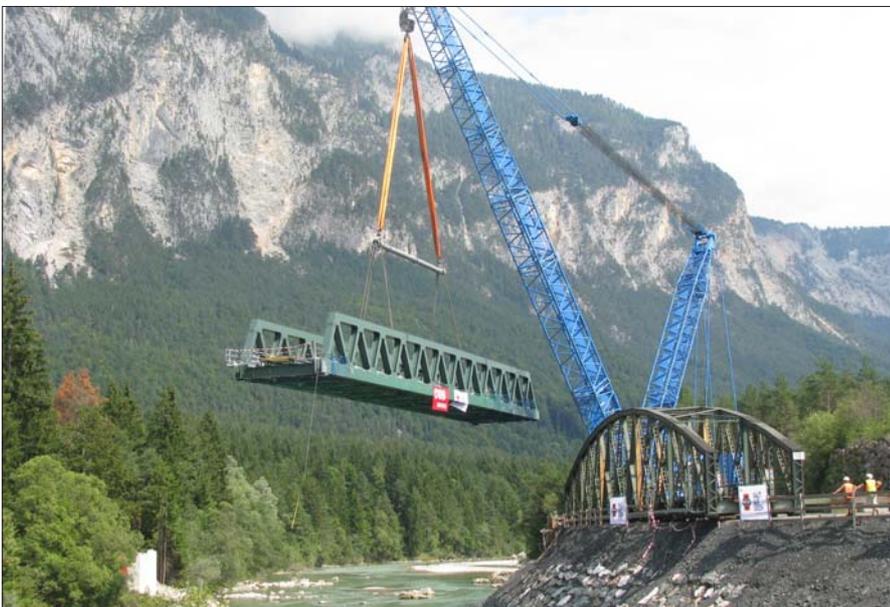
Lifting the new bridge structure into position
