## THE METROPOLITAN, 1100 VIENNA

Client: BH-02 GmbH

Development Period: 2018 to 2020

### THE PROJECT

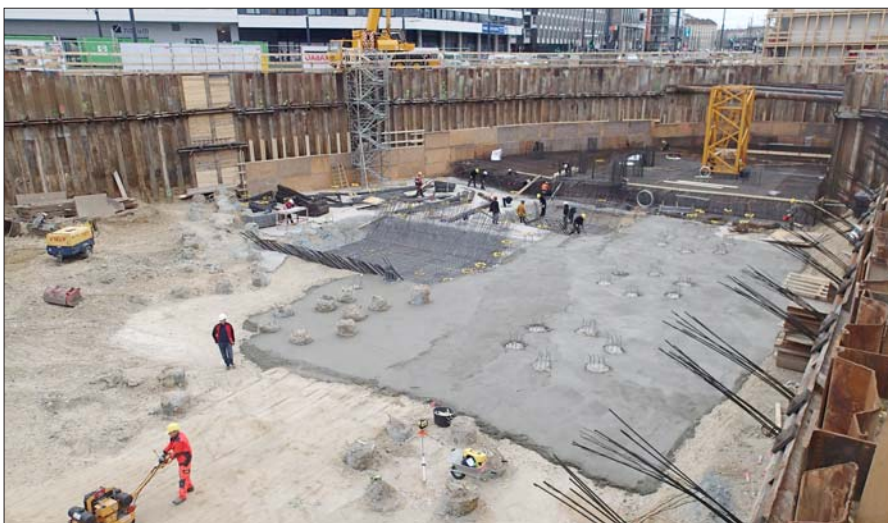
*View into the construction pit; At the left edge of the picture excavation area of the sealing wall for the tar pit remediation*

At the southeastern corner of Building Plot A, a sealing wall (jet grouted sectors) of a tar pit remediation is located. The upper edge of the pit is situated only slightly below the foundation level of the new building. A damage of the sealing wall by the load of the structure had to be avoided.

Possible impacts of the construction on the sealing wall were examined by means of 3-dimensional finite element settlement analyses. Based on the results, the building foundations were optimised and special measures defined.
