## VIENNA - SALZBURG HIGH PERFORMANCE RAILWAY LINE, ST. PÖLTEN MAIN STATION

Client: ÖBB-Infrastruktur AG (Austrian Railways Infrastructure AG)

### THE PROJECT

### OUR FUNCTION

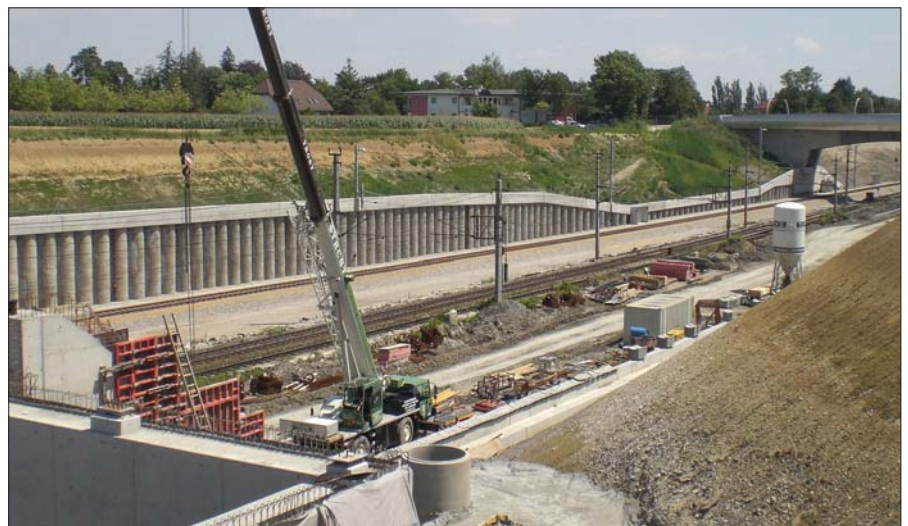
*Cut at the western section (view towards east), retaining structure in form of an intermittent bored pile wall*

In the section west of the station, the railway line crosses a geological fault zone, the so-called St. Pölten Fault. For this reason, particular attention had to be paid to the design and the dimensioning of the cut extensions, especially because of the high ground water level.

Therefore, the retaining structures were designed in form of intermittent bored pile walls with shotcrete noggings on both sides of the line.

Instabilities that occurred locally were secured by means of slope flattening, riprap or anchors. In this way, a cost-effective construction at a sufficient safety level could be secured.
